Photo Log

Stony Ford Road – Ford Farms

by Andreescu, Stephanie

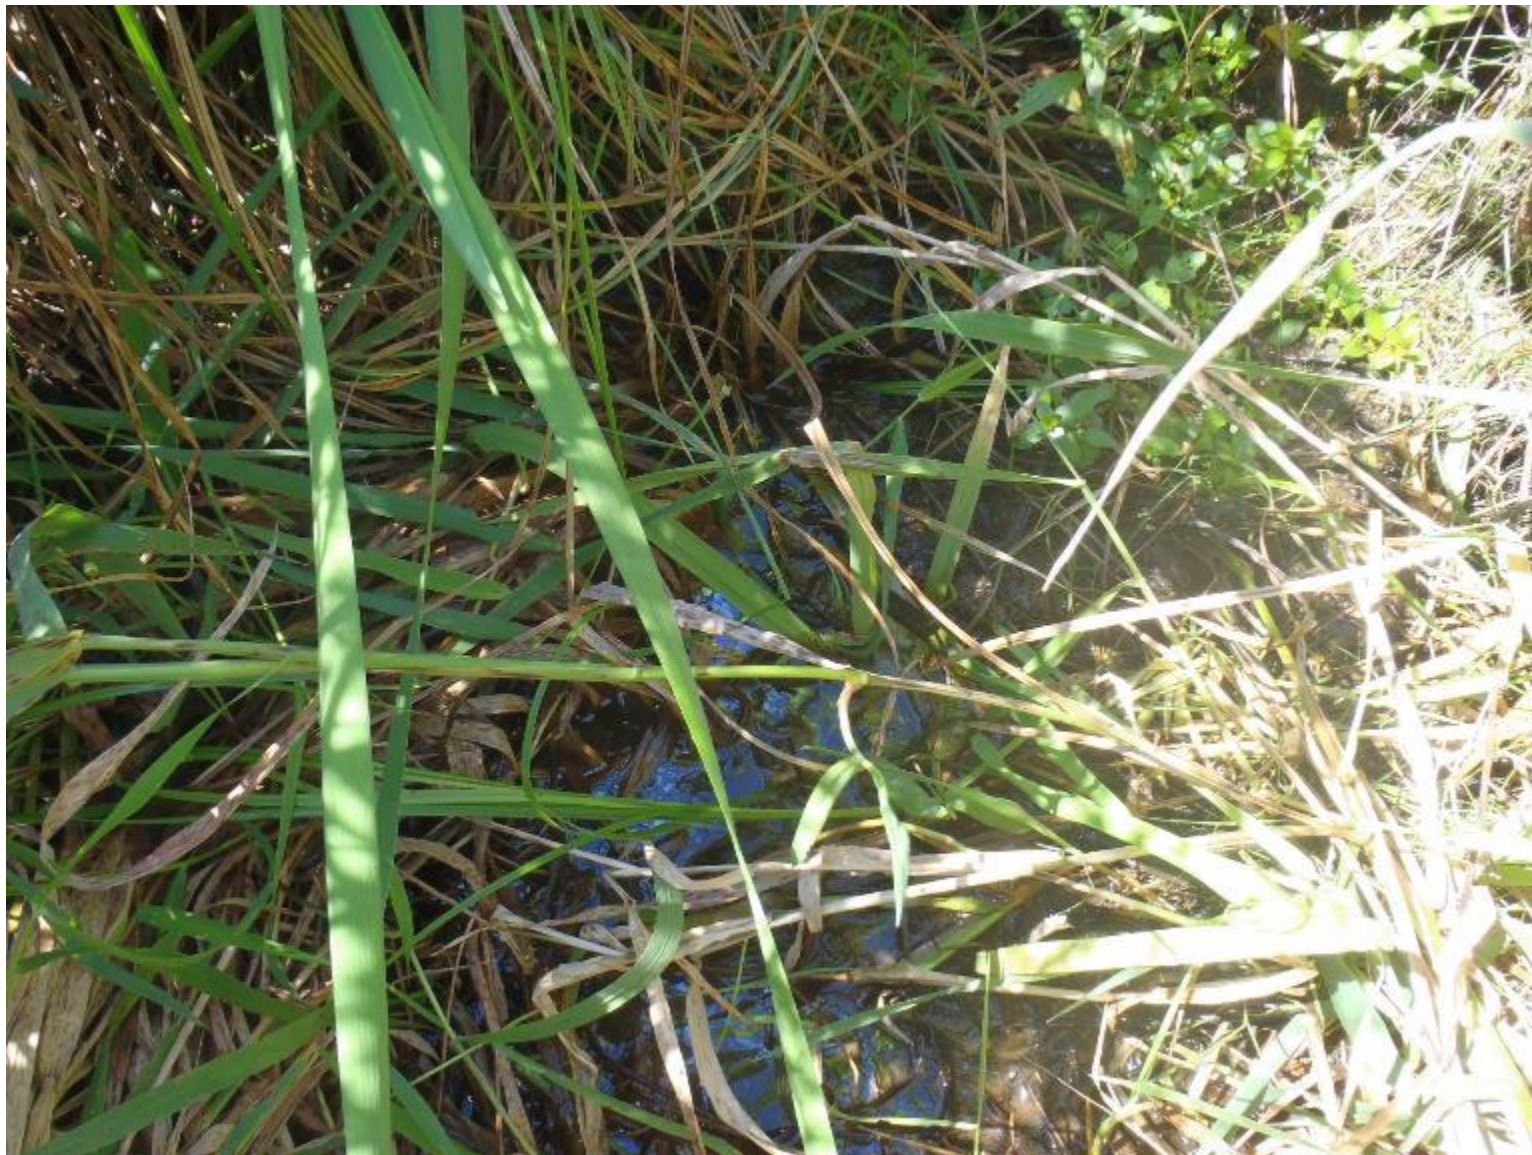
P9220014 – Wetland Area, Documentation of Standing Water, Cattails

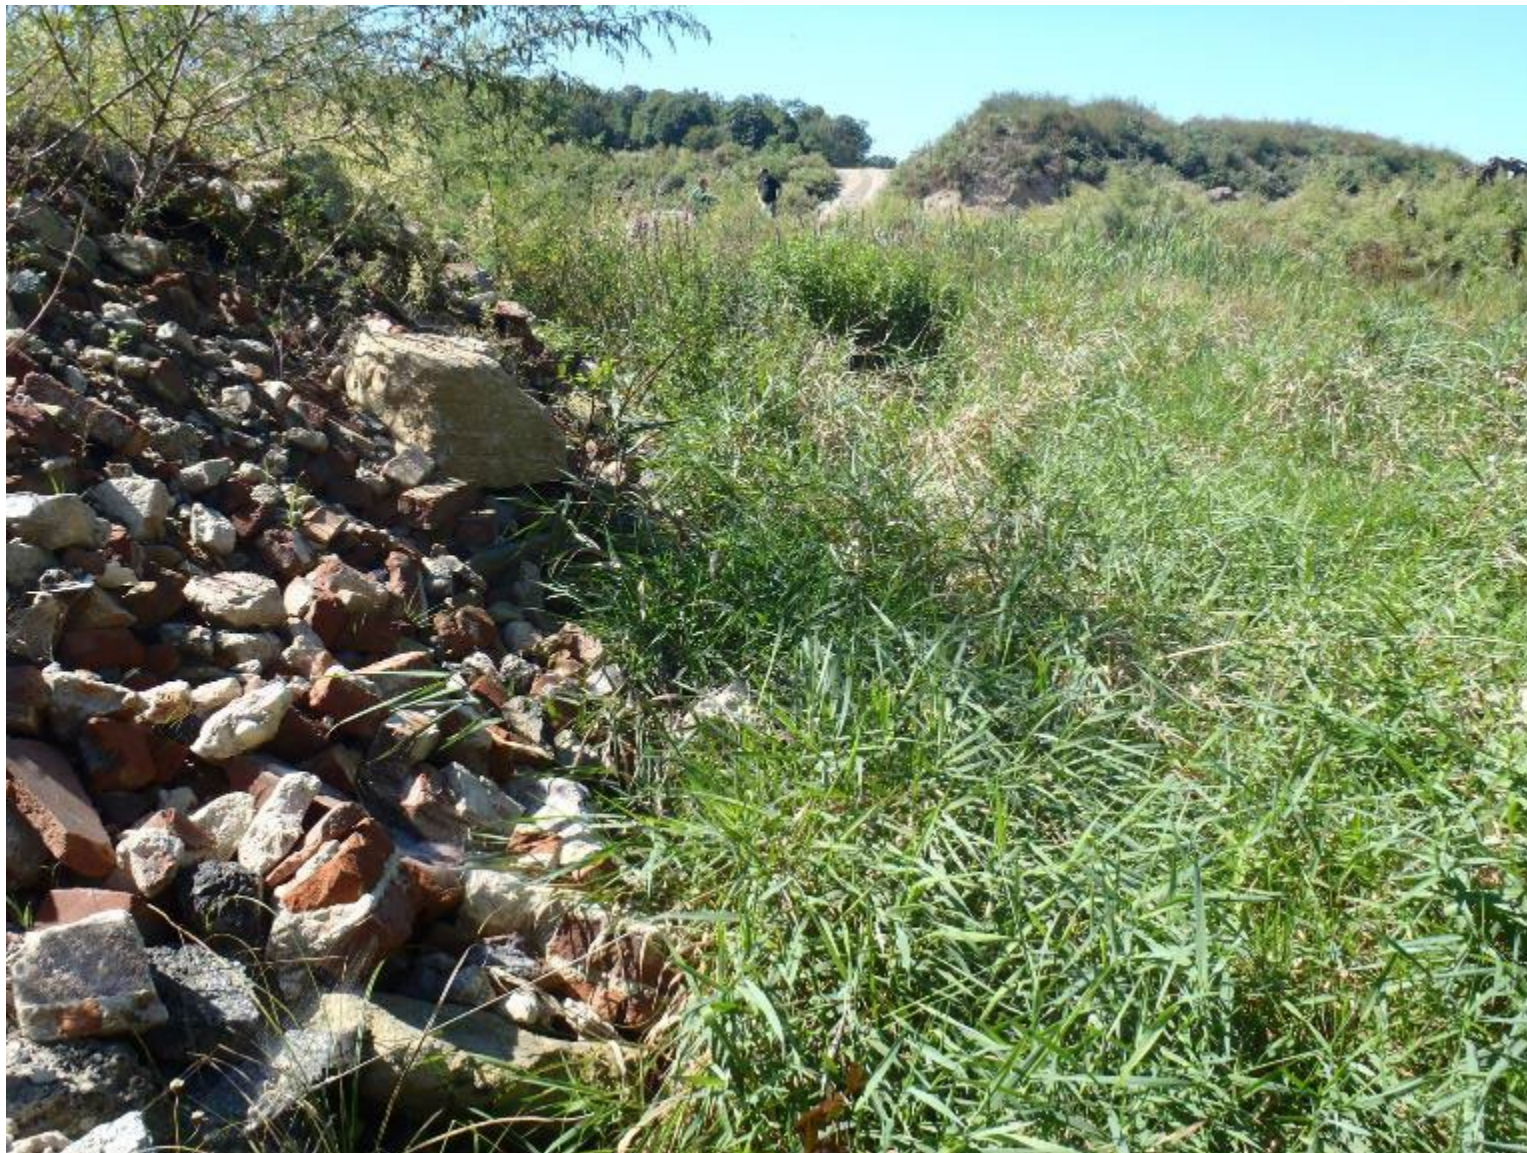
P9220015 – C&D Material Placed in Wetland, Facing West

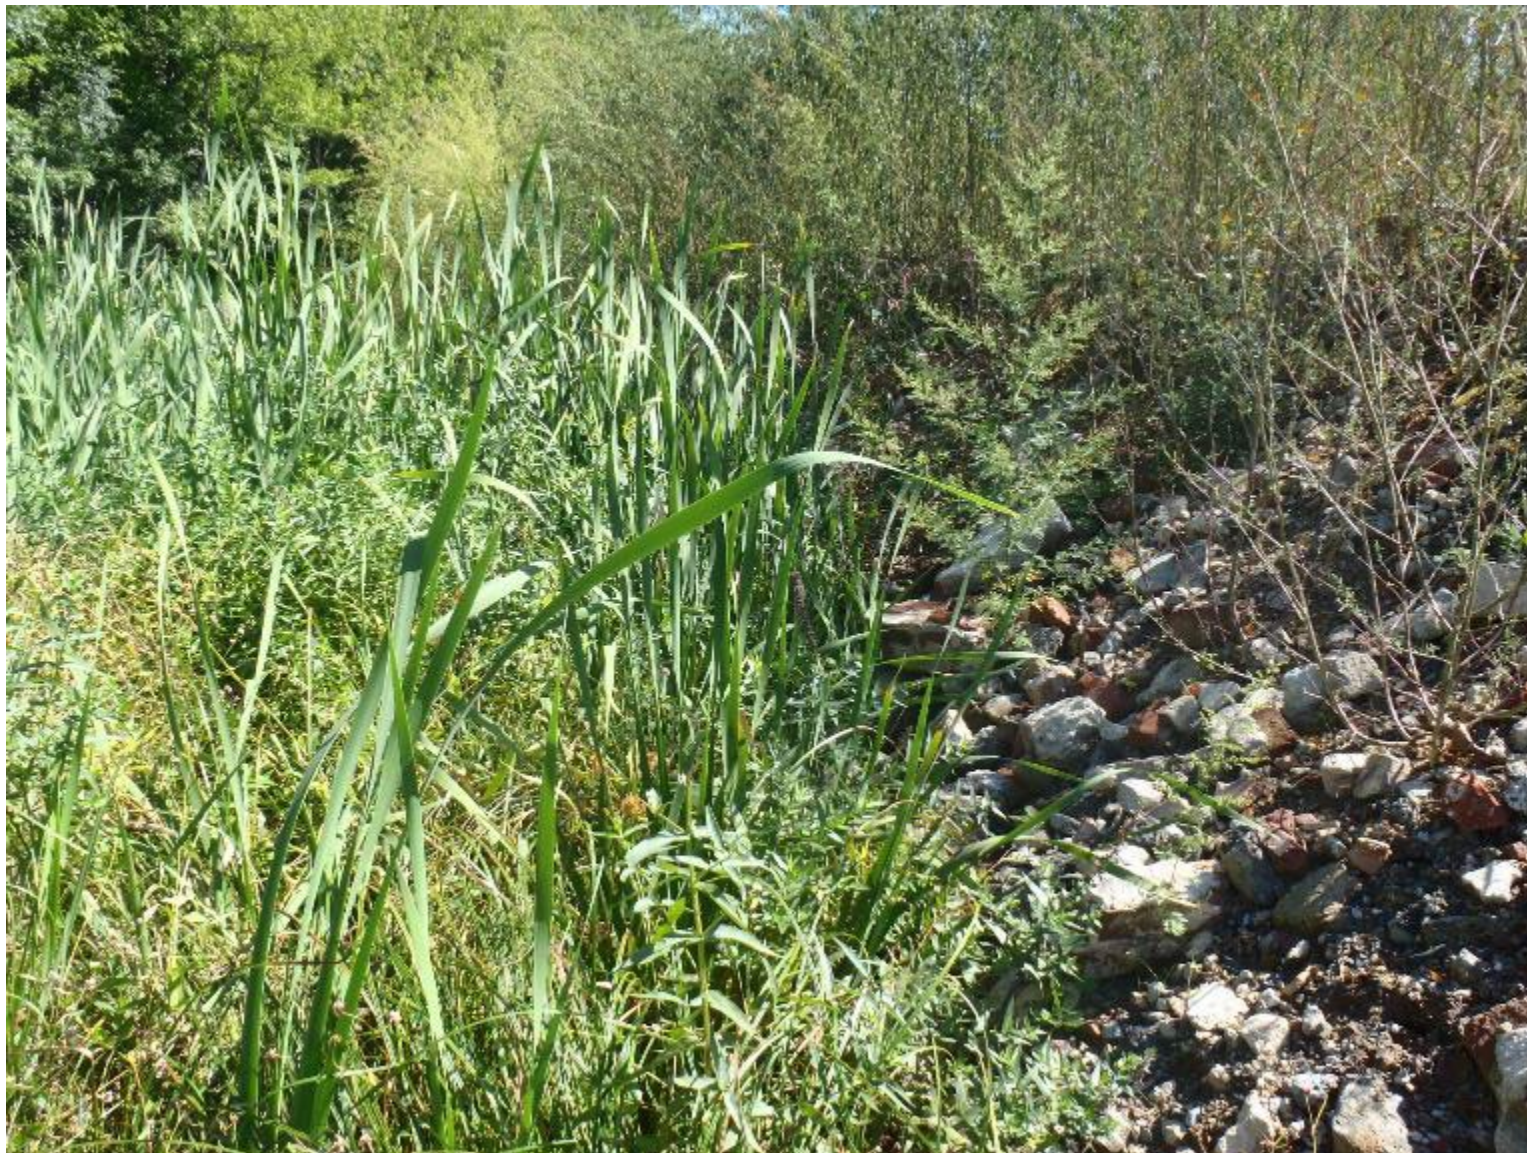
P9220016 – C&D Material Placed in Wetland, Facing East

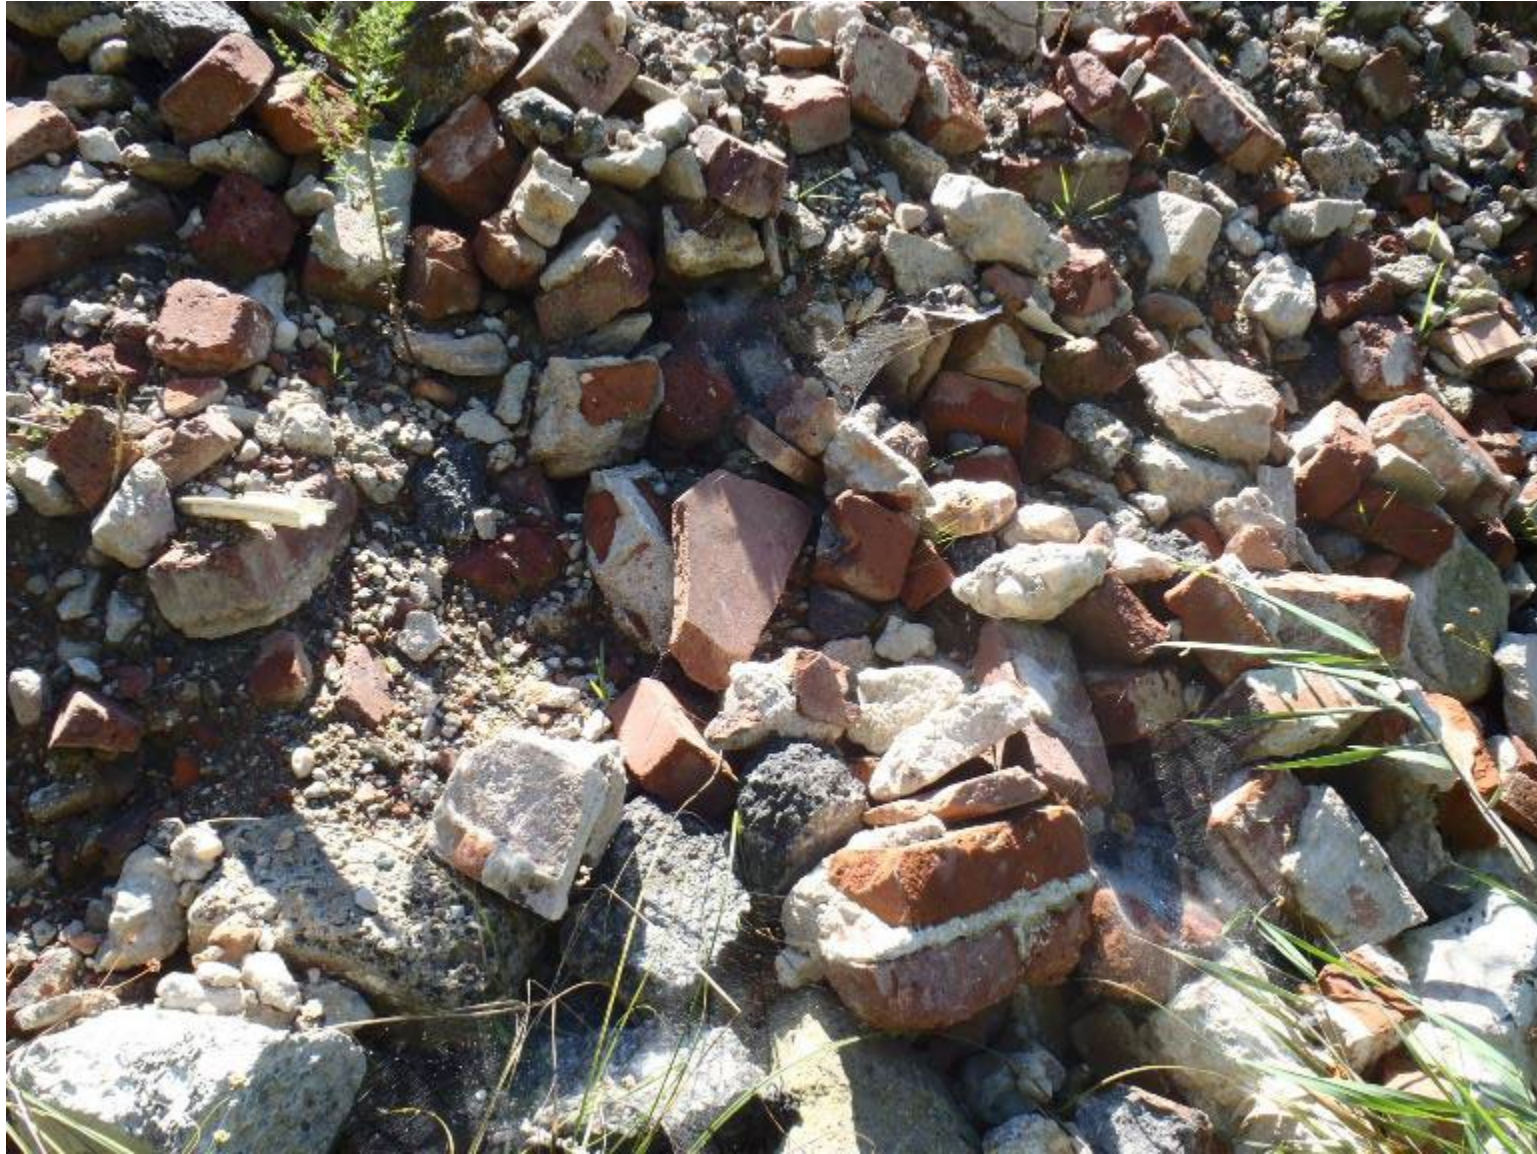
P9220017 – C&D Material Placed in Wetland

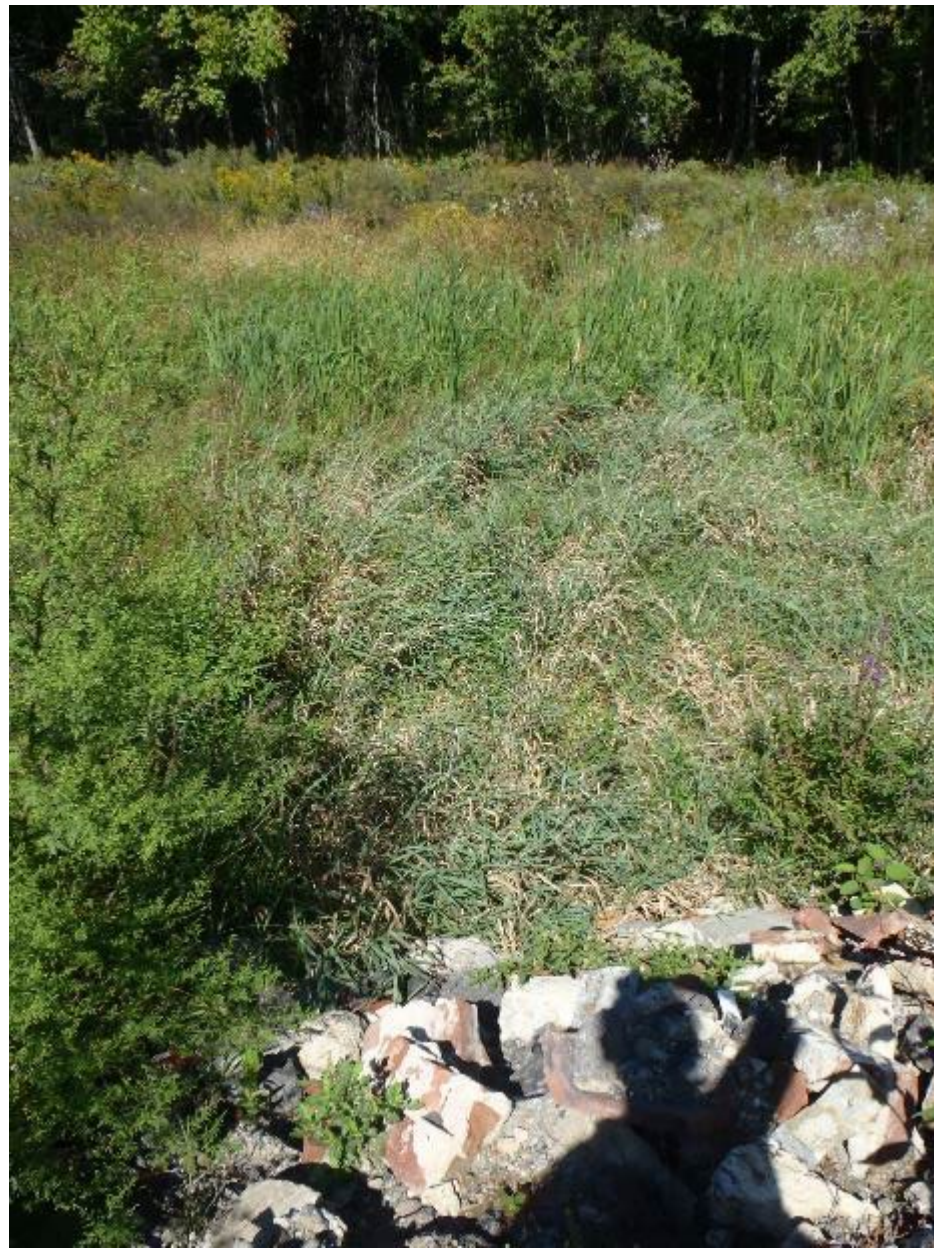
P9220018 – C&D Material Placed in Wetland

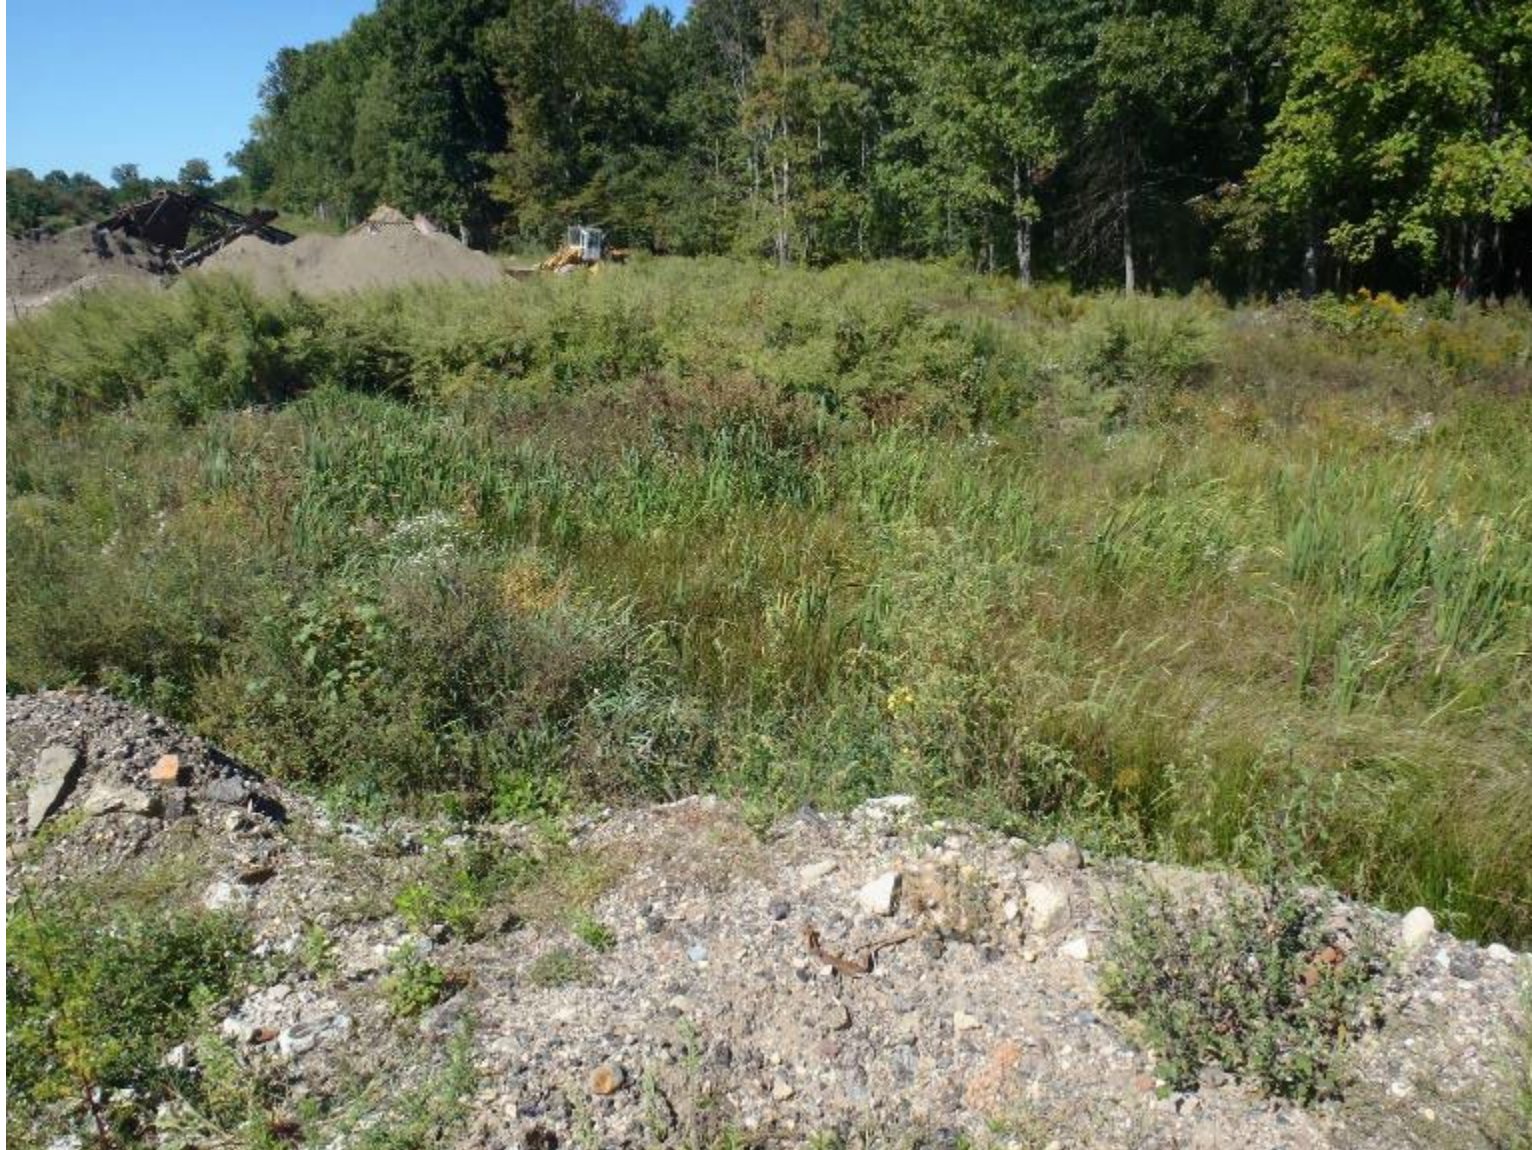
P9220019 – C&D Material Placed in Wetland, Looking Northwest

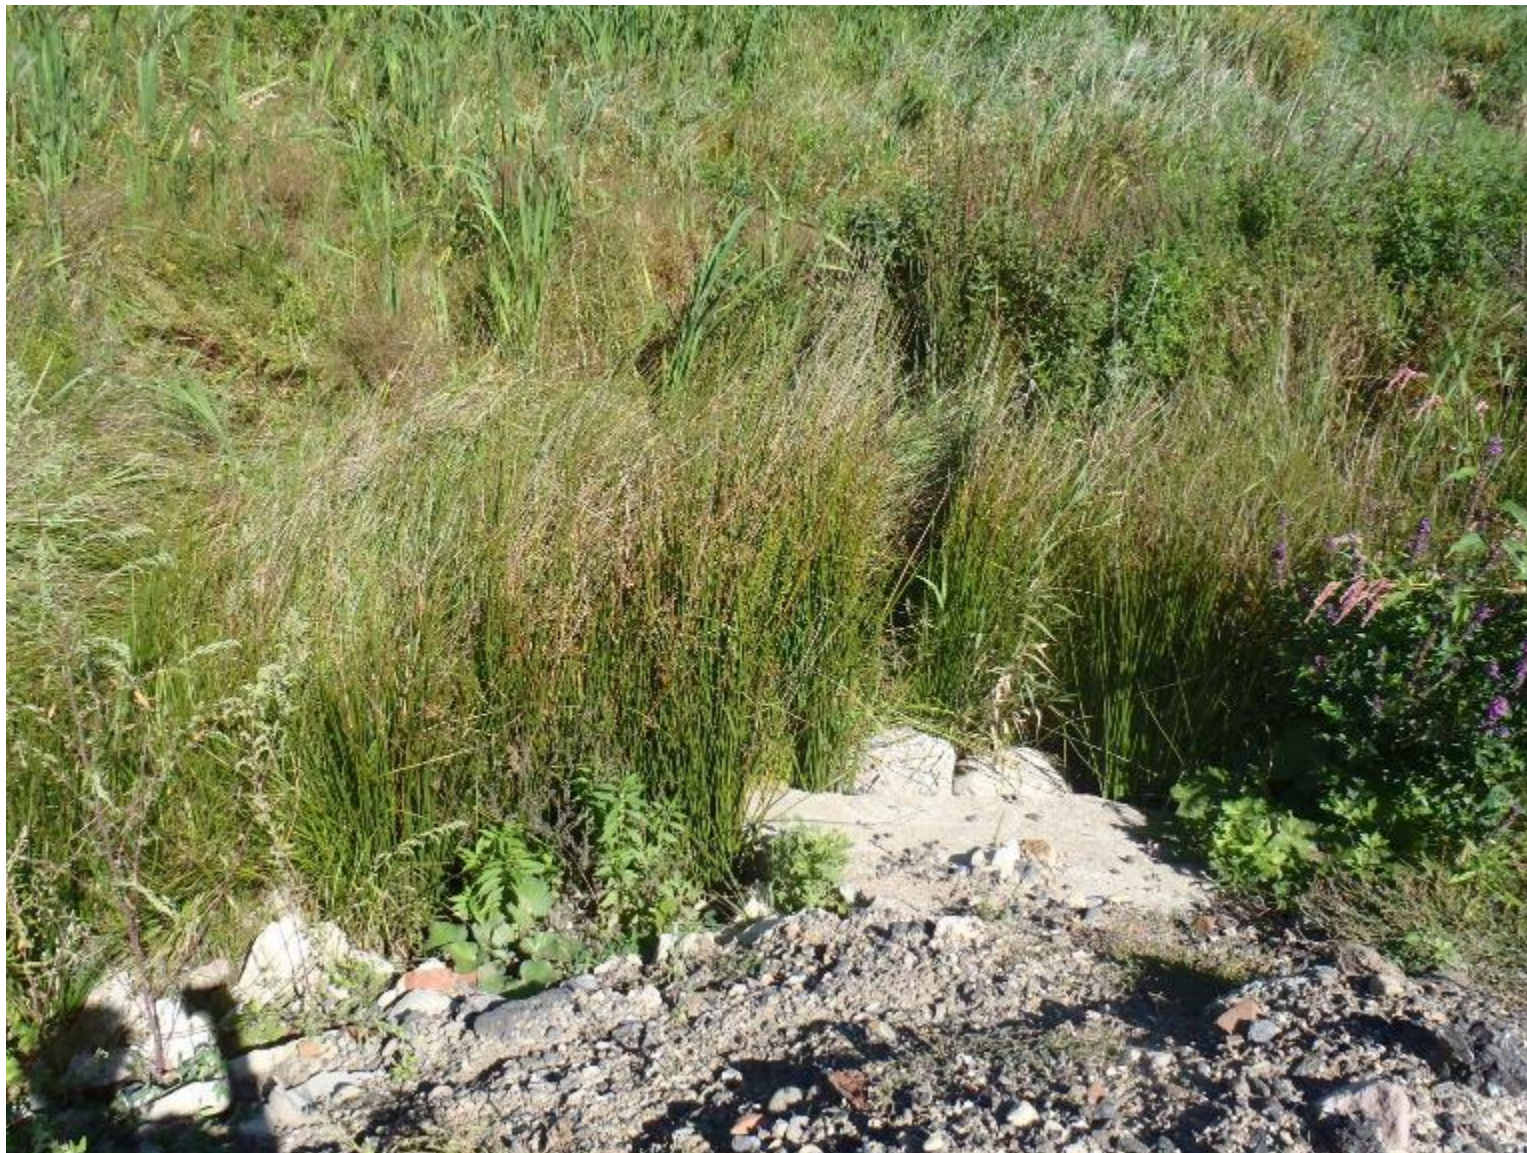
P9220020 – C&D Material Placed in Wetland, Soft Rush

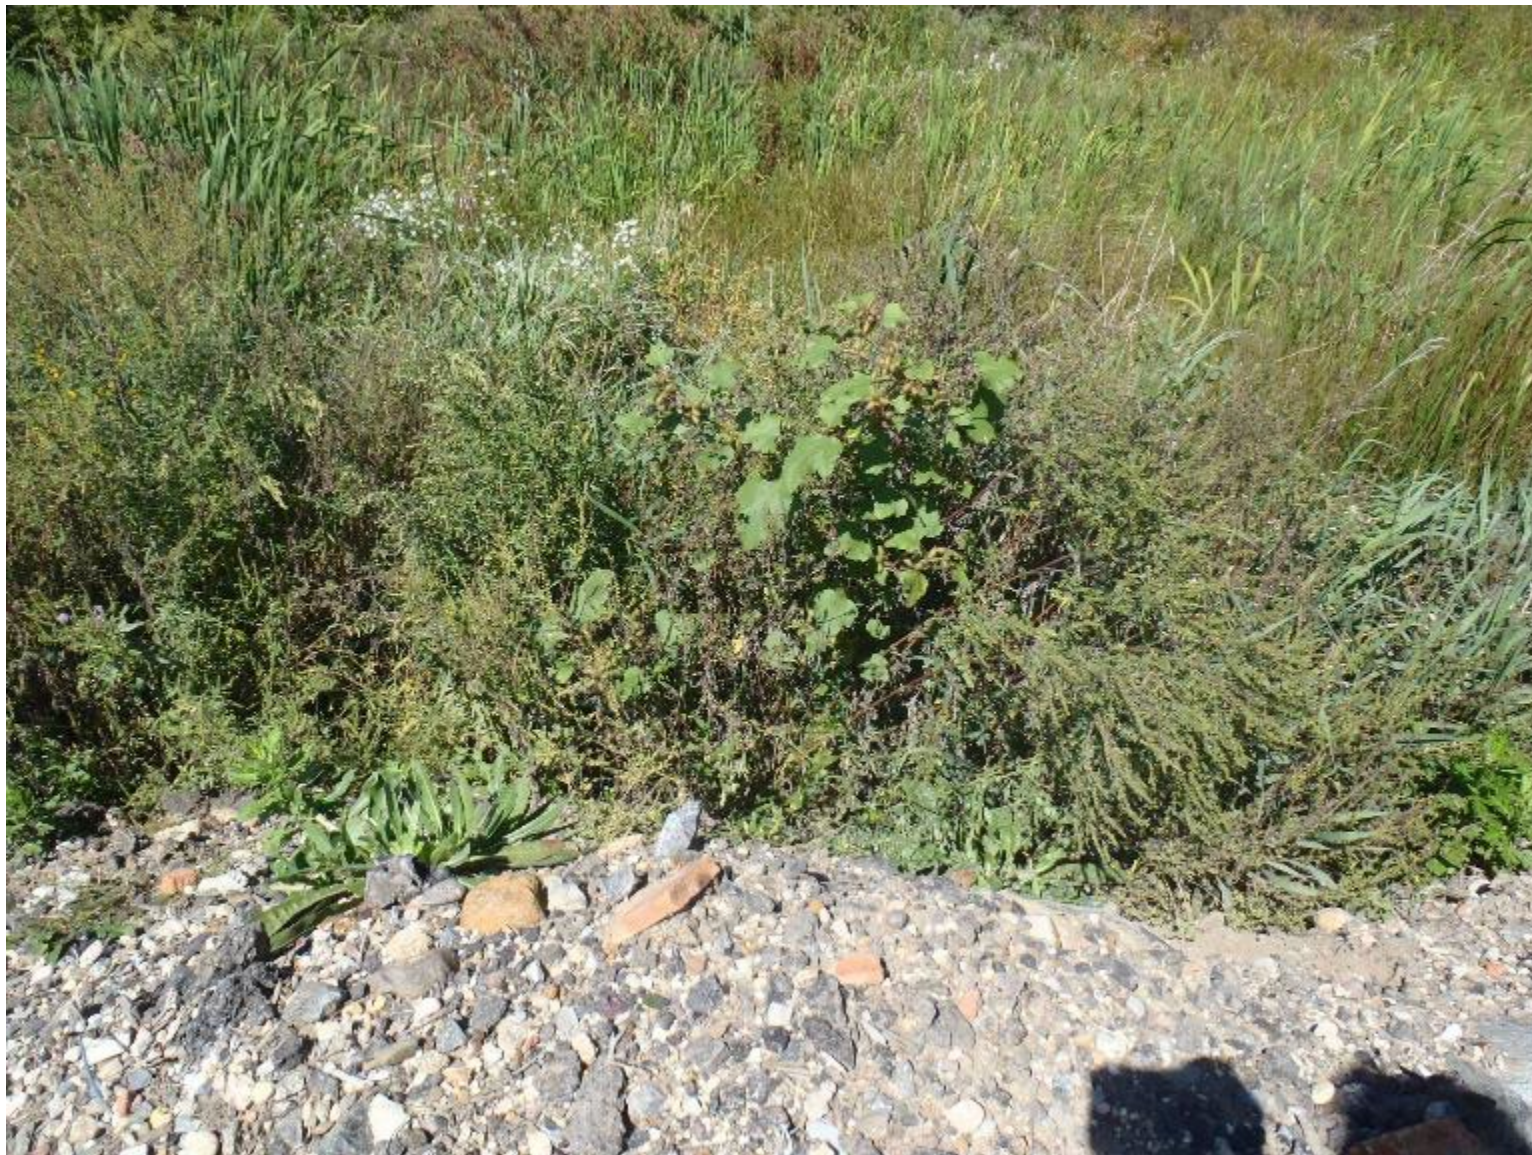
P9220021 – C&D Material Placed in Wetland

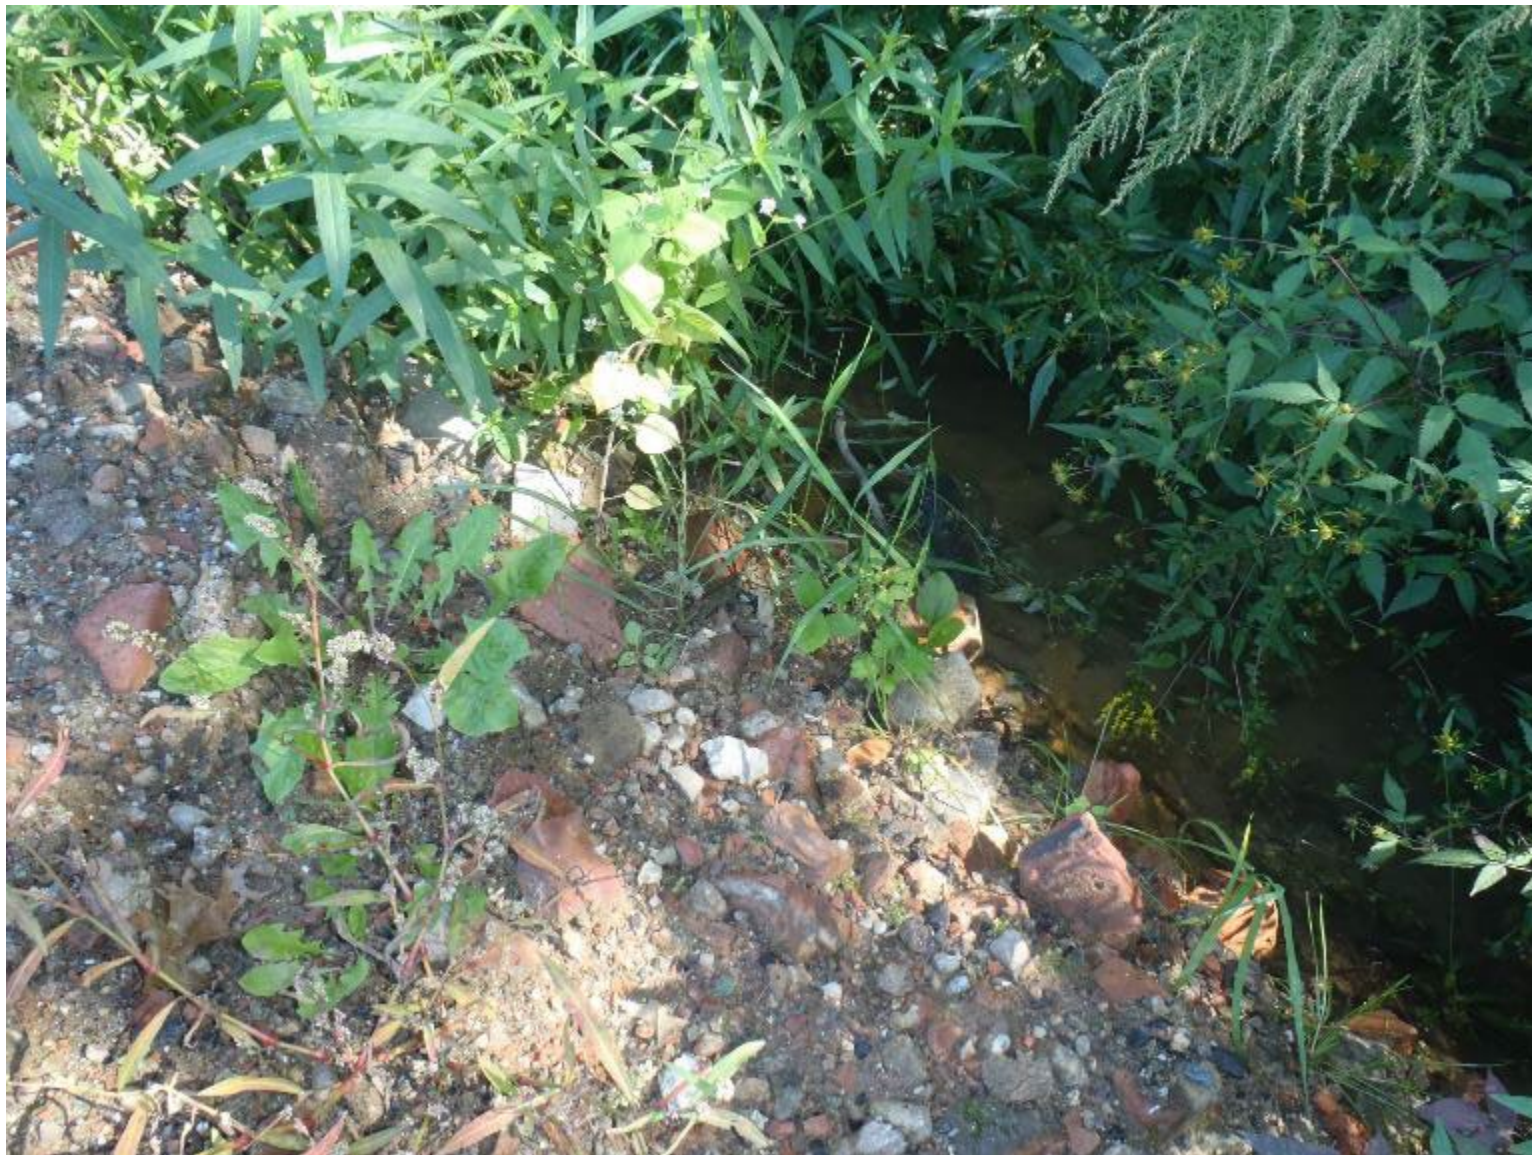
P9220022 – Relocated Stream, C&D Material Forming Right Descending Bank

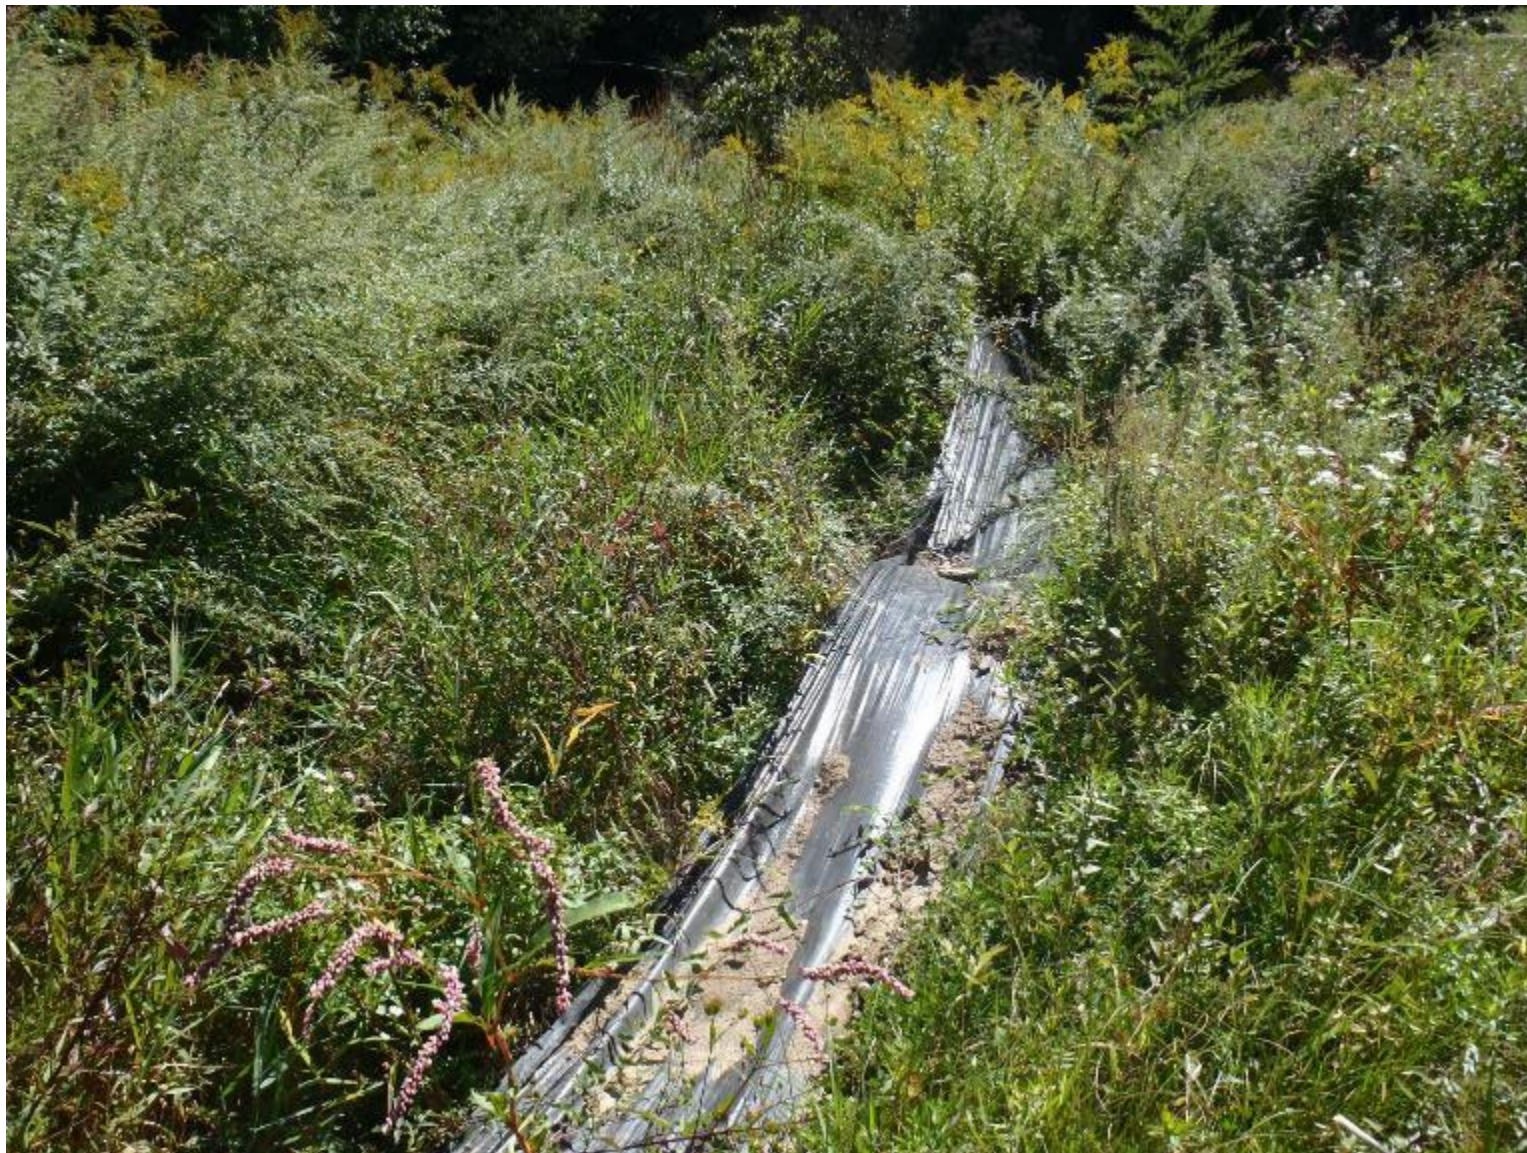
P9220023 – Compromised Silt Fence Along Relocated Stream, SE Border of Property

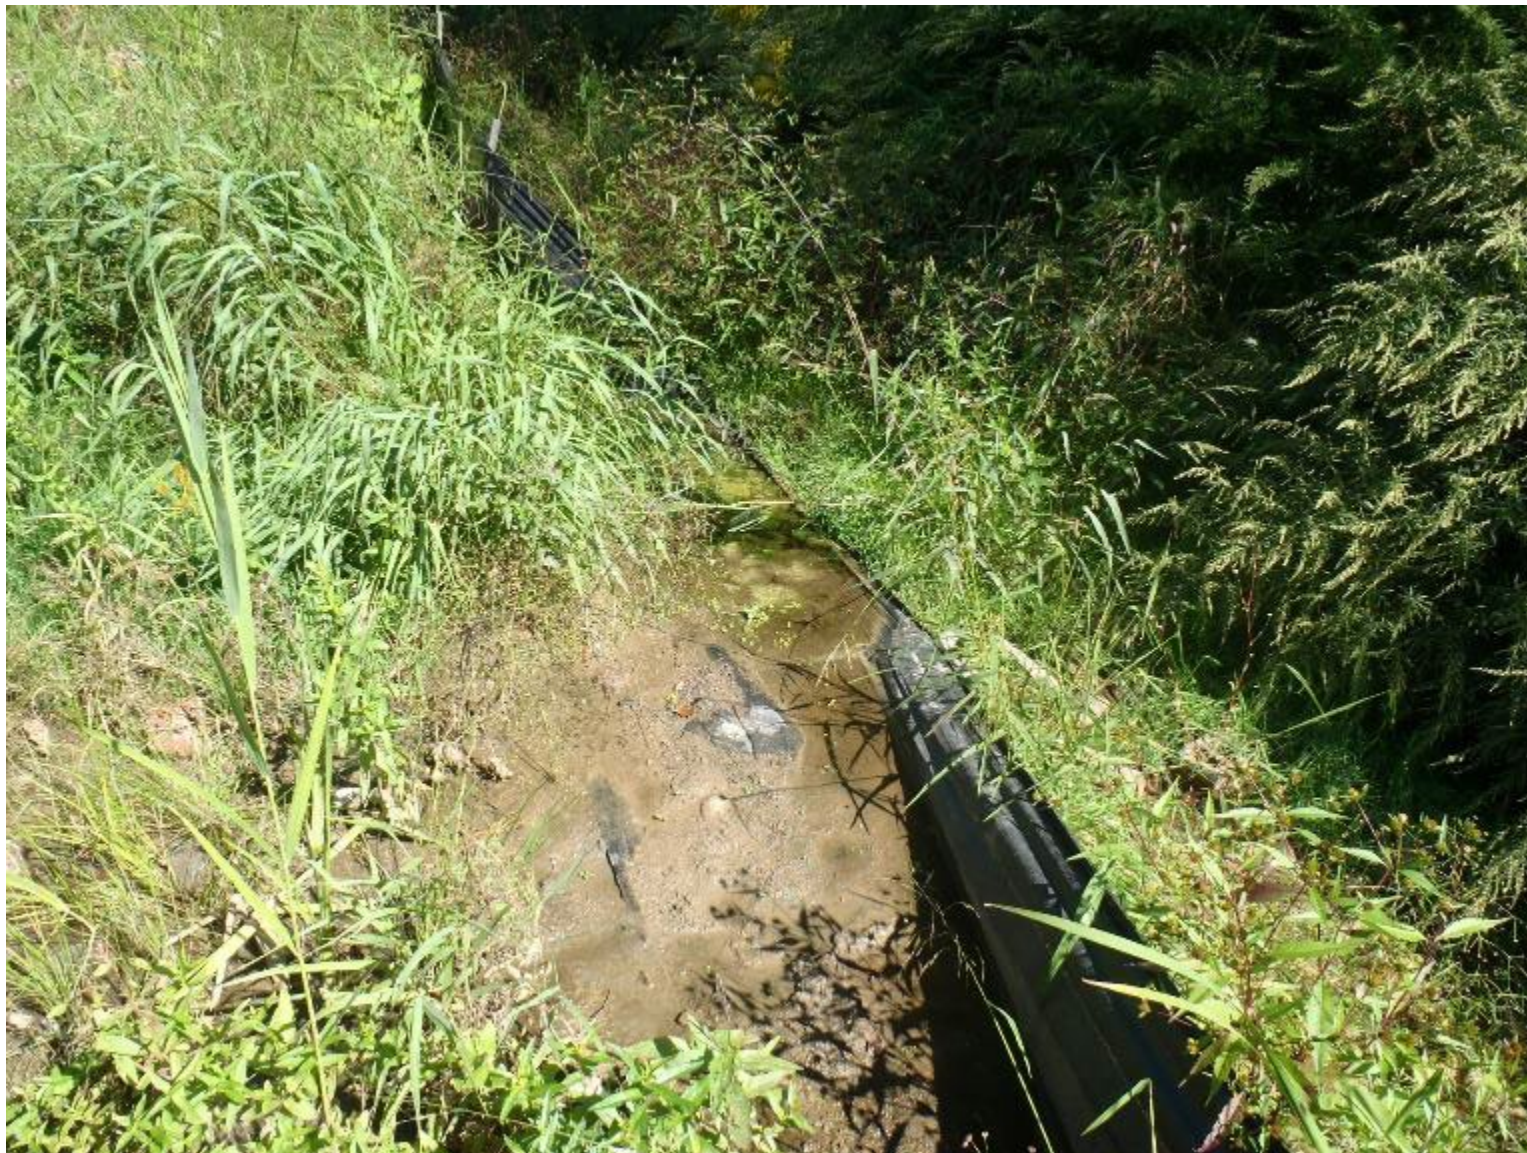
P9220024 – Silt Fence Along Relocated Stream, SE Border of Property

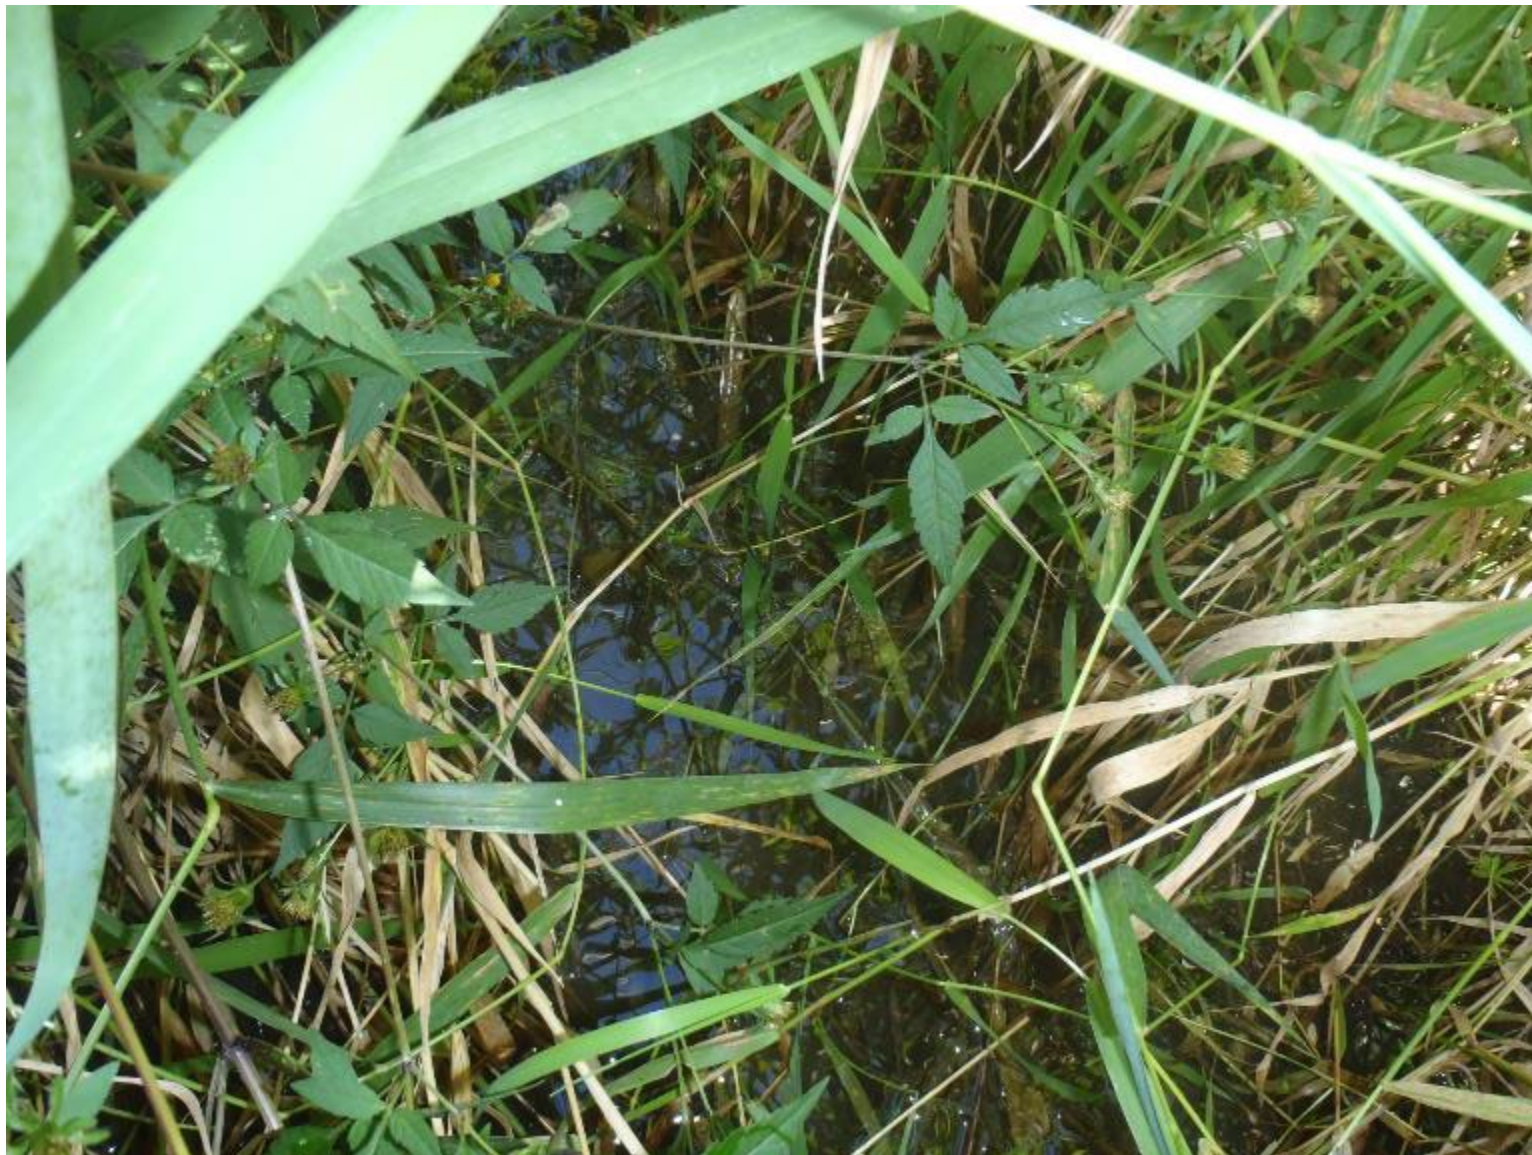
P9220025 – Narrowed Stream Leaving Site

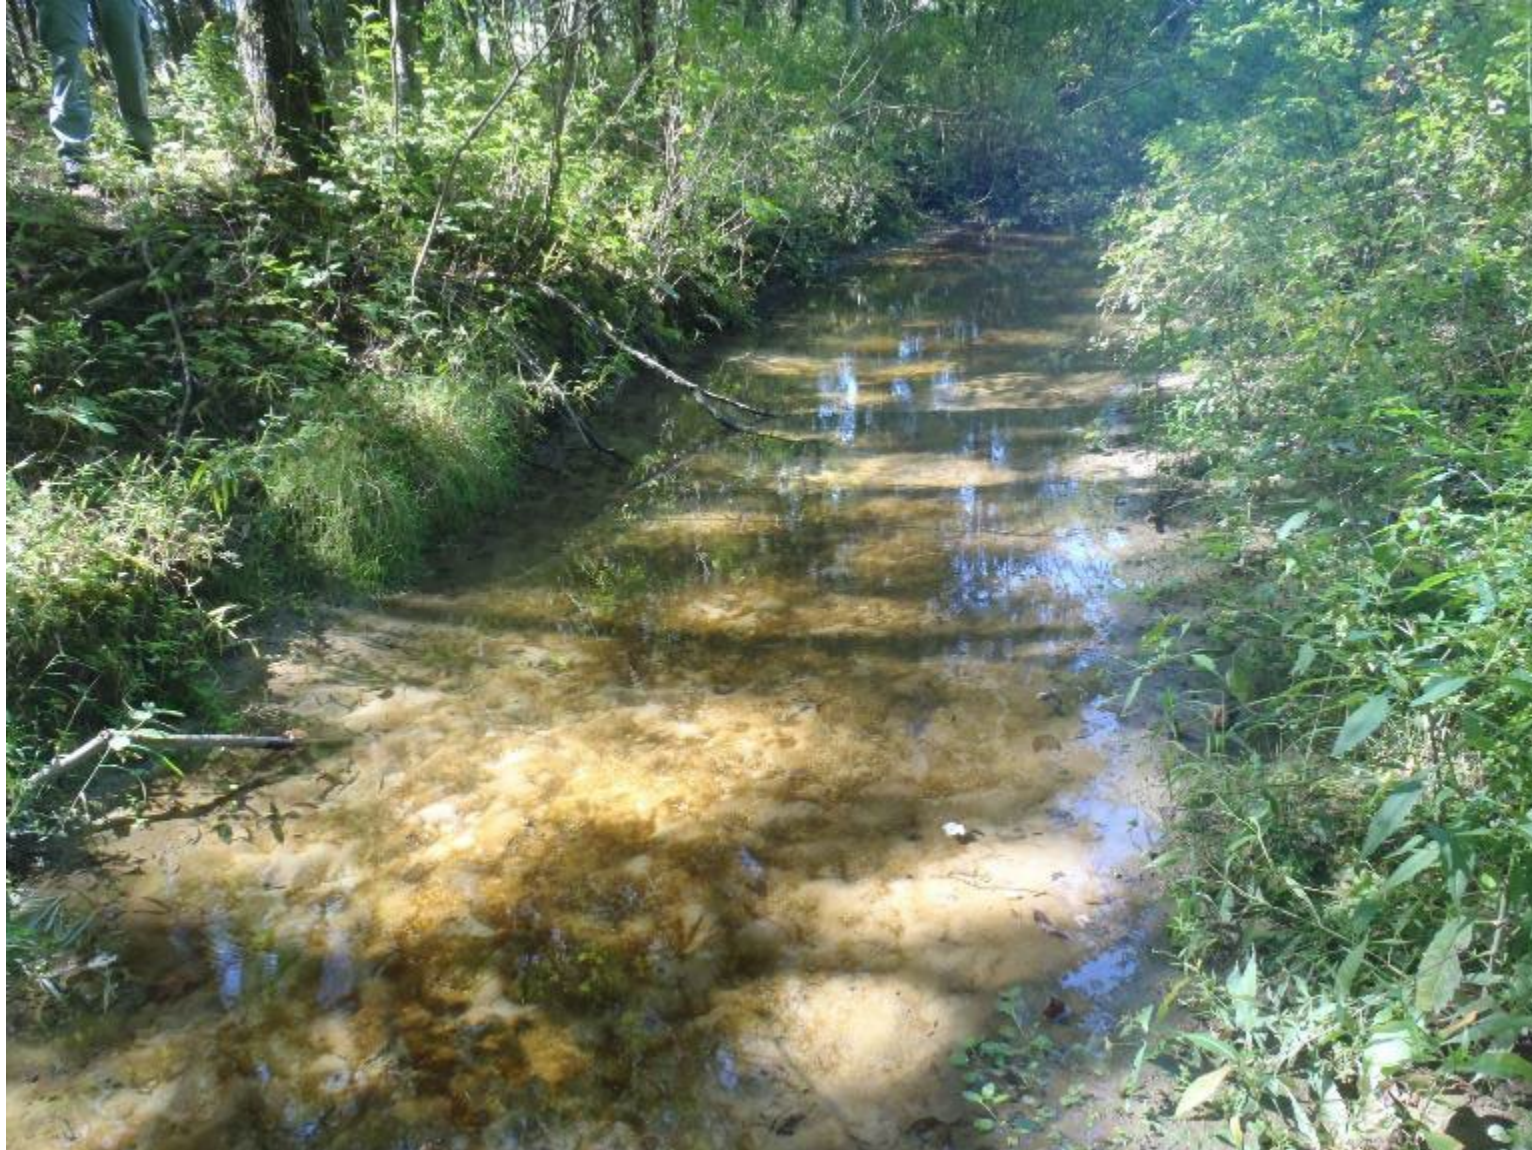
P9220026 – Downstream of Site, Looking Upstream
